I have a CAT800 hot tub bought in August of 2004. It has been working just fine until recently. Usually I leave my system on year-round; however, it gets the majority of its use in the colder months (I'm in NJ). This year I noticed that more water was needing to be added than I could justify as being due to evaporation, so this past summer I decided to shut off the system and allow it to "leak" off to the point where I could then determine (based on the height of the standing water) where the leak was.

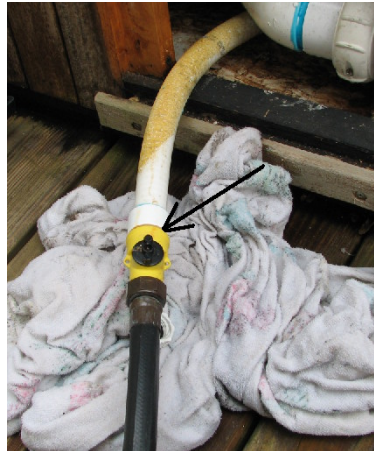
I found "one" leak (hint: there are more). Turned out to just be the drain-hose connection (see below), so I just put some plumber's pipe tape around it and that was that...

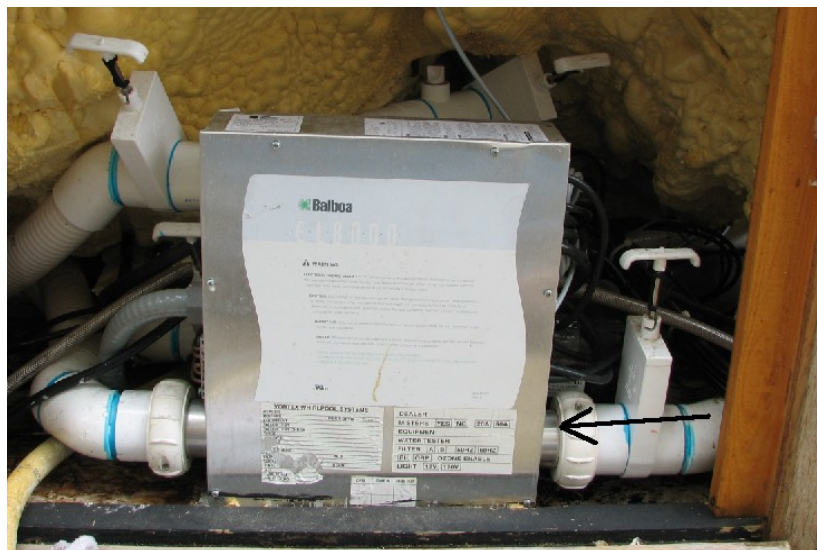
So, I proceeded to clean and refill the tub and that's when things got bad. There were no noticeable leaks after simply filling the system. I turned on the pumps individually, purged the air and all was still ok. Shortly after this though there was at least one leak (bad: spraying), right at the union into the heater (see below)...

So, I am looking for the parts-list I would need to be able to replace the seals (assuming there are O-rings or something in there) at the union. I may as well replace both sides (right?). Also, since there was water "spraying" out at that point, I'm not sure if there may be other leaks (how likely is that?). Would I be best off to replace the seals in the pumps as well? If yes, can you point me to the correct parts based on my system being a CAT800? I can take more pictures if that would be helpful. Any other preventative maintenance you could recommend at this point would be helpful. I may as well do it while I have the system opened (I'm also re-finishing the wood panels, so the tub is getting a make-over).
